**CREATING A FRAMEWORK FOR THE SUCCESSFUL
IMPLEMENTATION OF ENERGY RETROFIT PROJECTS: A
DETAILED CASE STUDY OF ENERGY RETROFITS IN
ATLANTA'S CHASTAIN PARK**

In Partial Fulfillment
of the Requirement for the Degree
Master of Integrated Facilities Management in the
School of Building Construction

Georgia Institute of Technology

May 2012

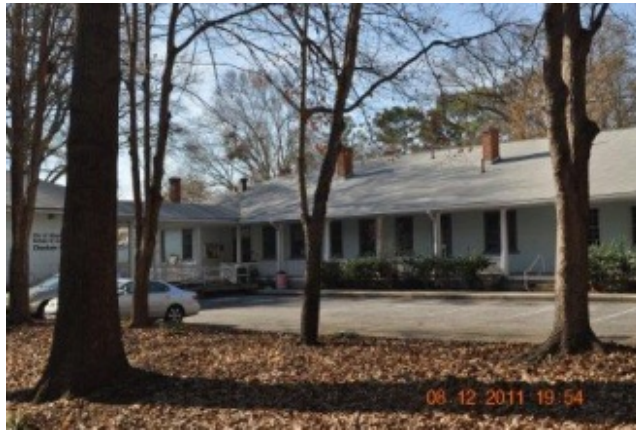
CHASTAIN ARTS CENTER

The Chastain Arts Center was perhaps the most extensive portion of the overall project due to its age and level of disrepair. The two single level buildings that made up the Arts Center combine for a total square footage of approximately 18,500 square feet. They were believed to have been constructed during the first decade of the 20th century, although additional evidence to support a more specific time was not available (OCA 2011). The facility included a large multi-classroom building where community arts classes of a various nature were held. Multiple areas of the building had been previously renovated at different times and two large porch areas had been enclosed. These renovations/additions were performed with little or no cohesive traits, thus leading to a building that had multiple wings with building systems that did not work in concert with one another. Further, there was no insulation of any kind present in any portion of the building. In addition to this main building, there was also a separate building connected to the Arts Center by way of a covered walkway that served as the Art Gallery. The buildings were originally almshouses (or poorhouses) for the elderly, disabled, and unemployable. The building that was being used as the gallery had originally served as

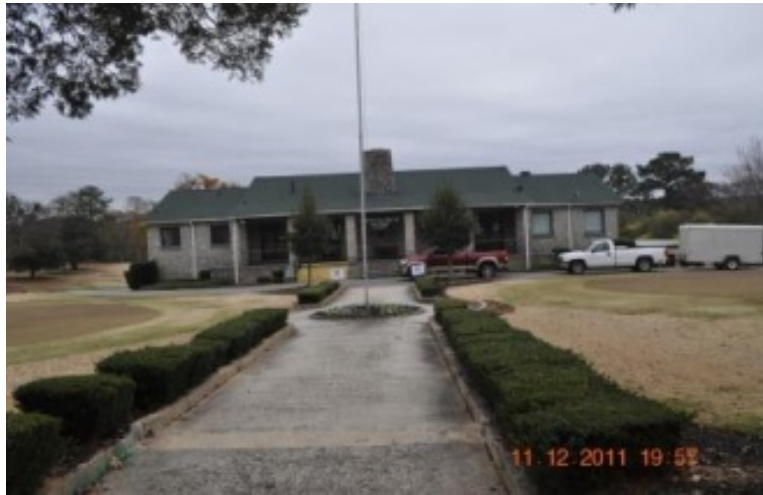
NORTH FULTON GOLF COURSE CLUBHOUSE

The North Fulton Golf Course was built in the 1940's. It is a two level masonry stone building with offices, a retail golf supply shop, and concessions upstairs and both men's and women's locker rooms downstairs. This facility's scope focused entirely on the upstairs portion of the facility, due to a planned renovation of the downstairs area (locker rooms) from another source of funds that included major demolition and replacement. The facility boasted a large stone fireplace in the center of a large pine paneling lined room that served as the retail pro shop and snack area. An acoustical tile "drop ceiling" was installed throughout the facility. At one end of the large room was an entrance to a short hallway that contained men's and women's restrooms and a large office. At the opposite end of the building were a kitchen, storage closet, and the general manager's office.
